COMMENTS OF HONDA MOTOR CO., LTD. **REGARDING CARB MAIL-OUT #94-35** "UTILITY AND LAWN AND GARDEN EQUIPMENT ENGINES **PROPOSED AMENDMENTS**"

CALIFORNIA EXHAUST EMISSION STANDARDS AND TEST PROCEDURES Part II, Section 2. Engine Test Set-up: Exhaust Gas Analytical System: Engine Parameters.

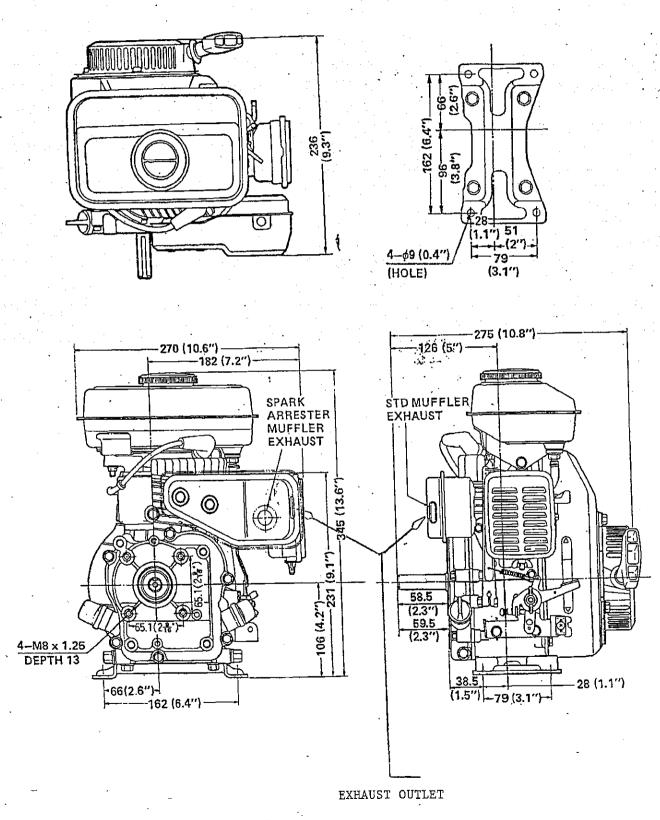
3. DIMENSIONAL DRAWINGS

Unit: mm (in)

- Basically, the exhaust gas regulations are intended to control the exhaust gas emitted from the engines, equipment or vehicles,
- The exhaust gases in the muffler are not necessarily equivalent to the gases actually emitted from an engine's tail pipe,
- 3. We must avoid ingesting air from the atmosphere due to pressure pulsation in the exhaust,
- 4. Some small ULG engines, such as the Honda G100K1, have no exhaust conduit and no tailpipe (see attached drawing),

5. It is difficult to locate the sampling probe directly in the muffler of small ULG engines because it is too small,

- If we locate a sampling probe in such a small muffler, the air from the atmosphere may be ingested into the sampling probe due to pressure pulsations in the exhaust and due to the small muffler size,
- 7. If we choose to use the mixing chamber, we will have to prepare mixing chambers of various sizes for our products depending upon engine displacement, and
- 8. Almost all 2 stroke engines for string trimmers would have the same problems mentioned above as G100K1.
