State of California
AIR RESOURCES BOARD

EXECUTIVE ORDER D-60
Relating to Exemptions under Section 27156
of the Vehicle Code

SUPERIOR INDUSTRIES, INC.

"ACCULITE ELECTRONIC RETROFIT IGNITION SYSTEM - MODEL NO. G8-24 AND A8-34"

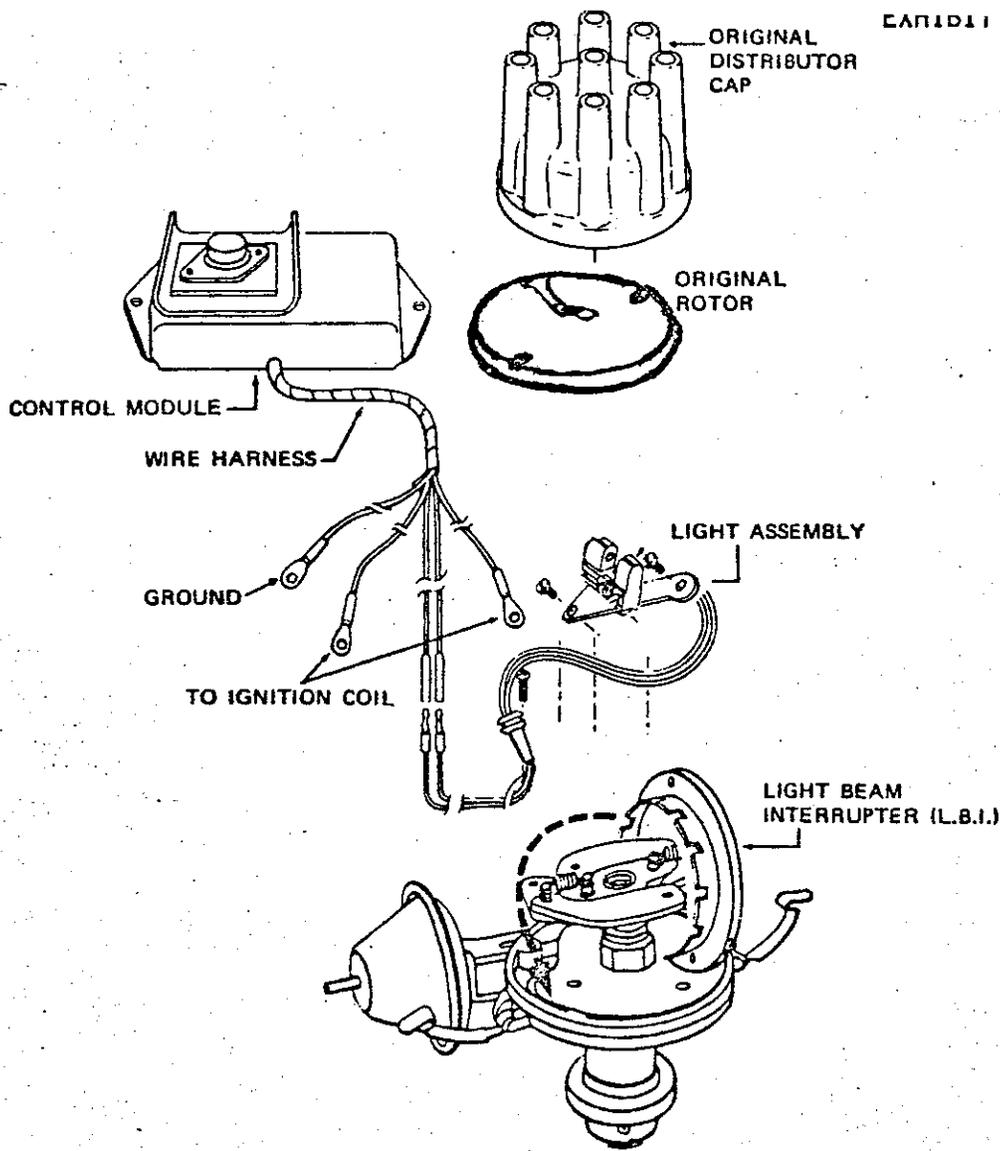
Superior has now developed such a breakerless ignition system as an aftermarket item so that it can be fitted to vehicles which originally were equipped with contact points. The owner of an automobile equipped with a breakerless electronic ignition system will find that the advantages of such a system are: greater reliability, more precise cylinder to cylinder timing, more precise firing characteristics, usually a hotter spark, and always a significant decrease in maintenance and service costs since there are no parts to wear out or alter ignition timing. This results in less frequent increases in harmful emissions because of point wear.

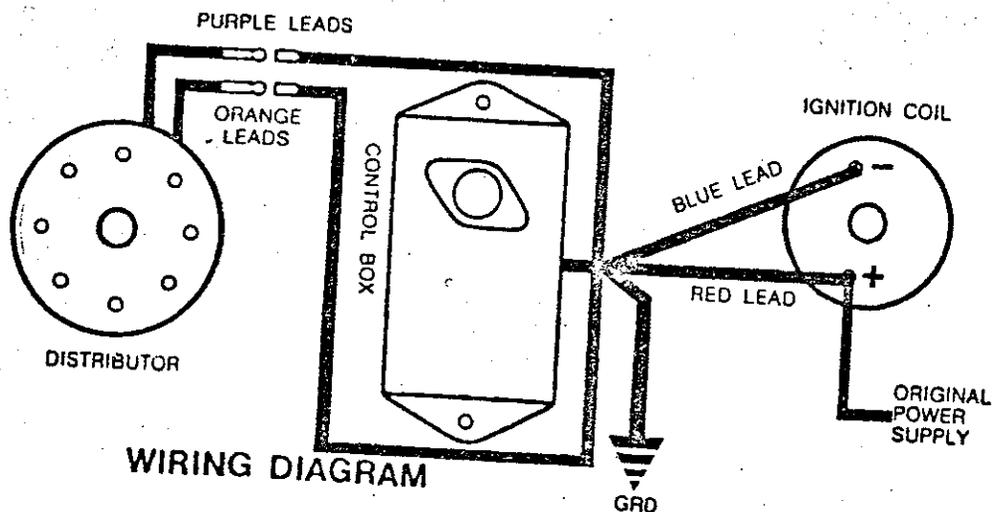
When receiving this signal, the control module breaks the coil ground connection to interrupt the current in the primary winding. This induces a high voltage in the secondary coil winding to fire the spark plugs. The length of time this flow is broken is determined by the slot width of the L.B.I. The "dwell" is built into the L.B.I. and is always correct.

The Acculite Ignition System, is designed to reduce regular ignition maintenance to cleaning or replacing spark plugs. The distributor components do not make contact, and therefore do not wear. Engine timing and dwell are built into the electronic system and do not require periodic adjustment.

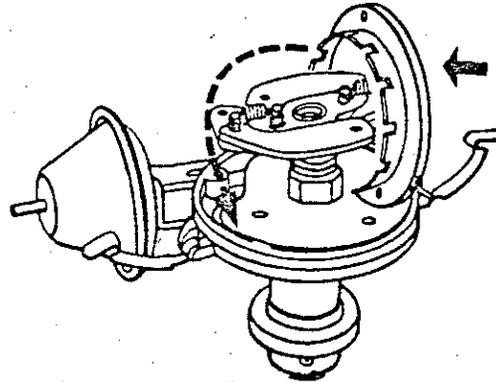
6. Position light device on base plate of the distributor. **DO NOT** align light device into its proper place at this time.
7. Take L.B.I. and slide at least half way over the centrifugal advance mechanism, align the L.B.I. into the opening on light device (see illustration). Let L.B.I. fall over the centrifugal advance mechanism and lay on base of distributor.

8. Position light device into place previously occupied by contact set and replace and tighten hold down screws firmly.
9. Using a good rotor, position it into its proper place, insert two screws and flat washers provided in package (6/32 x 3/4), lift L.B.I. up and align screw holes to rotor hold down screws.
Important: Visually check to insure that L.B.I. is seated inside of rotor skirt. Now tighten screws... but **DO NOT** over tighten.
